# Sudden loss of the deep brain stimulation effect with high impedance without macroscopic fracture: a case report and review of the published literature

**Abstract:** The number of deep brain stimulation (DBS) hardware complications has increased during the past decade. In cases of abnormally high lead impedance with no evidence of a macroscopic fracture, optimal treatment options have not yet been established. Here, we present the case of a 49-year-old woman with a 12-year history of Parkinson's disease who received bilateral subthalamic nucleus DBS in March 2006. The patient showed good control of parkinsonism until December 24, 2010, when she awoke with abrupt worsening of parkinsonian symptoms. At telemetric testing, lead impedances were found at  $>2,000 \Omega$  in all four leads on the left side. Fracture of a lead or an extension wire was suspected. However, radiological screening and palpation revealed no macroscopic fracture. In June 2011, the implantable pulse generator (IPG) was changed under local anesthesia without any complications. Postoperatively, her parkinsonism immediately improved to the previous level, and the lead impedance readings by telemetry were also n

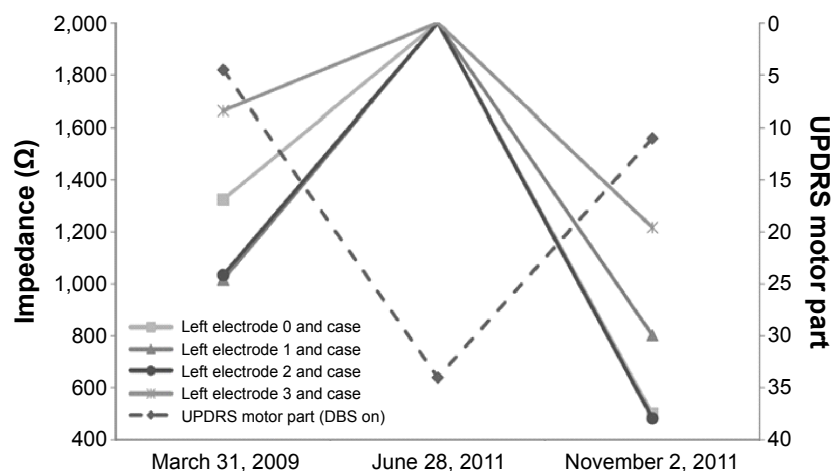
Prior to reoperation, her UPDRS motor scores with DBS stimulation were 34 with medication and 30 without (Figure 1). The scores without stimulation were 48 and 45, respectively. On June 29, 2011, the IPG was replaced under local anesthesia without any complications. Postoperatively, the patient's parkinsonian symptoms immediately improved under the same neurostimulator settings. The lead impedance readings on the left side were normalized. The extracted neurostimulator showed no visible signs of deformity. When tested with an oscilloscope at 1,000- $\Omega$  load impedance, the neurostimulator could produce stimulation waveforms. The destructive analysis by the manufacturer revealed that the case feed-through wire was lifted on the hybrid side, and this finding was consistent with the disconnection between the IPG hybrid circuit board and the connector block of the IPG header.

During a follow-up period of 4 months with amantadine at 300 mg/day, no recurrence of parkinsonian symptoms or high impedance measurements were reported. On November 2, 2011, her UPDRS motor scores were 11 with DBS stimulation and 34 without (Figure 1). In the 2 years after

**Figure 1** Changes in lead impedances and UPDRS motor part scores before and after neurostimulator replacement.

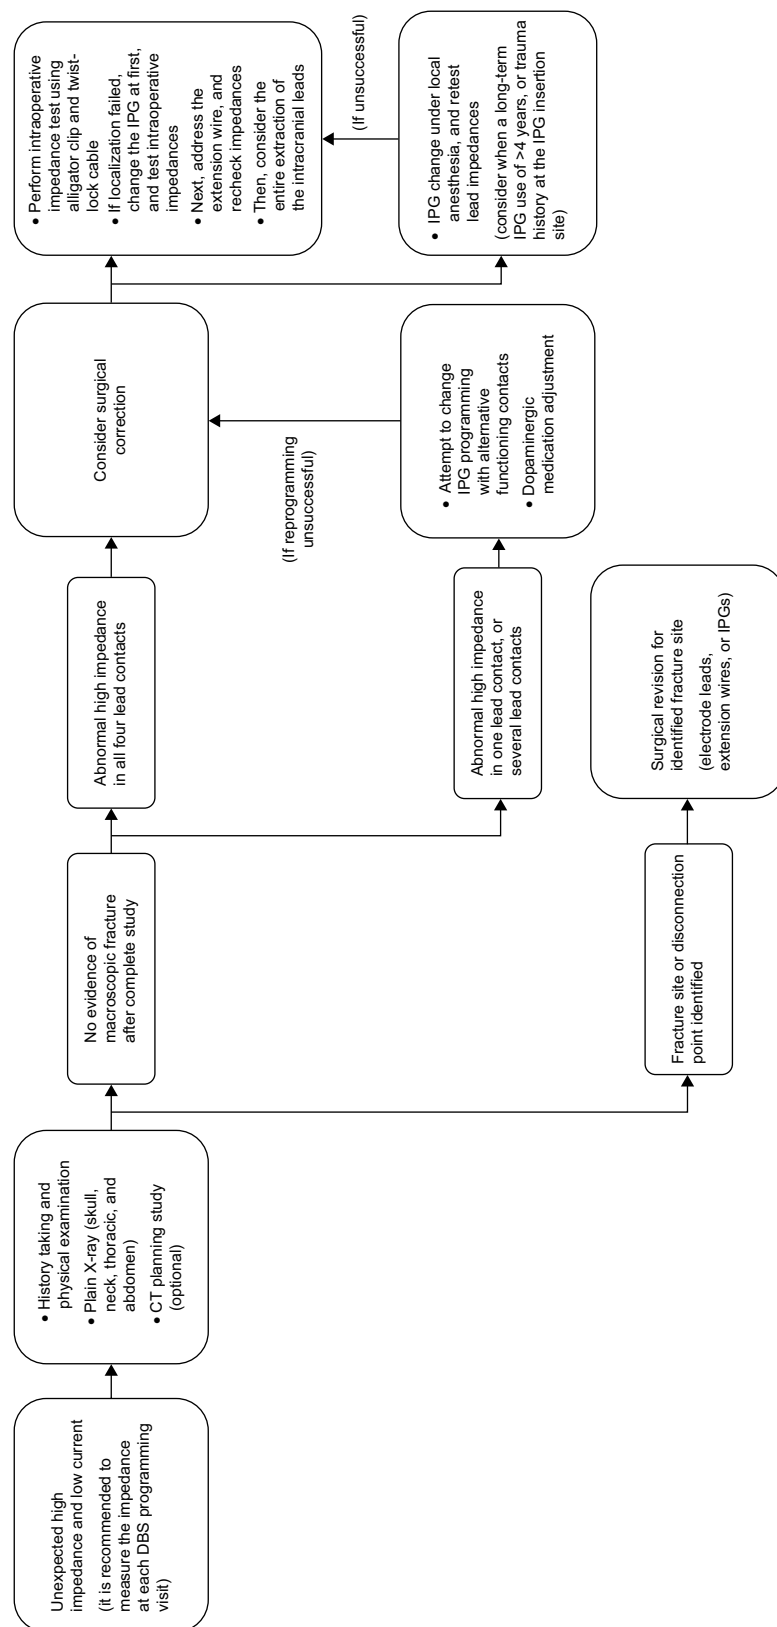
**Figure 2 A** suggested algorithm for assessing and troubleshooting hardware failures with high lead impedance and open-circuit state in a DBS system.  
**Abbreviations:** CT, computed tomography; DBS, deep brain stimulation; IPG, implantable pulse generator.

In cases of abnormally increased lead impedance and open circuit without a macroscopic fracture, the optimal treatment options are still not established. A proposed algorithm for assessing and troubleshooting those specific cases is presented in Figure 2.<sup>1,2,6,17</sup> Conventional IPG replacement under

local anesthesia is simple, and it can be performed in cases with unexplained high lead impedance before the decision is made to replace the electrode leads or extension wires. This approach may be preferred in patients with either a long-term IPG use of more than 4 years,<sup>20</sup> or a trauma history at the neurostimulator insertion site (Figure 2).<sup>8,15</sup> On the other hand, some cautionary notes should be sounded. The neurostimulator replacement procedure can cause several complications, such as infection or damage to the lead extender. If there is no clinical improvement after the IPG change, the extension wire replacement with a direct intraoperative testing of the intracranial leads during surgery should be the next step of management (Figure 2).<sup>1,6,14</sup> This staged approach can spare intact leads and extensions, and avoid unnecessary replacements and complications.
