# Role of physical properties of dental restorative biomaterials in criminalistics

**Abstract:** The body of an 89-year-old woman was discovered at home by a member of her family. Only part of the body, the legs, were found intact without burn damage. The rest of the body was burned to ashes without the possibility to identify the cadaver. Forensic Dentistry had two main goals to resolve in this forensic pathology casework, and they were: 1) establish the identification of the cadaver; and 2) estimate the temperature and the direction of the fire by the analysis and interpretation of the skeletal intraoral dental materials altered by thermal processes. This case study manuscript focuses only on the second objective. The effects of fire on teeth are influenced by the temperature applied and by its duration. Additionally, adjacent tissues as well as temperature alterations caused by substances used to quench the fire have been shown to affect the thermal impact on teeth and their restoration. Bodies may be subjected to various temperatures, depending on the origin of the fire and the conditions that promote continuation of the blaze. Fire effects on certain dental materials can indi

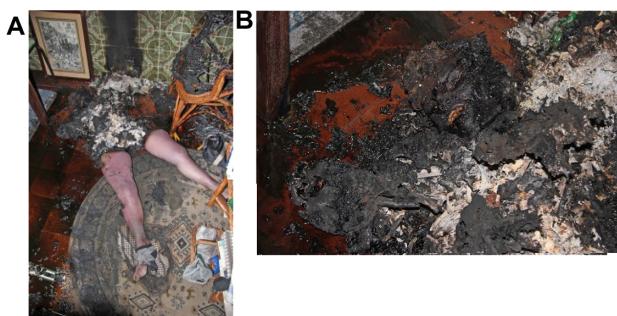
**Figure 1** General findings at the scene.

**Notes:** (A) Context of human remains after the fire: the legs without any burn damage and the rest of the body, except the skull, with complete cremation; (B) the skull was burned beyond recognition.

The body of an 89-year-old woman was discovered at home by a member of her family. Only part of the body, the legs, were found intact, without burn damage from the fire. The rest of the body was burned to ashes (Figure 1).

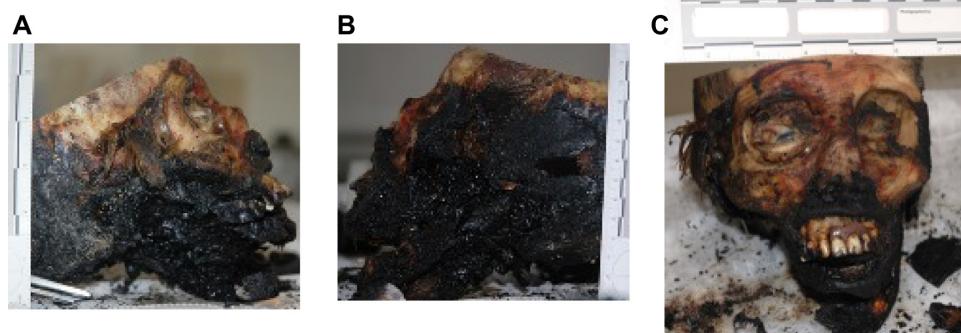
**Figure 2** The (A and B) lateral and (C) frontal views of the skull.

After removing the soft tissues from the skull, the hard tissues showed several degrees of burn damage. The skull had more extensive burn destruction in the lower third than in the upper third (Figure 2). The right side of the skull showed more burn damage than the left side, with more bone fragmentations, mainly in the lower jaw.

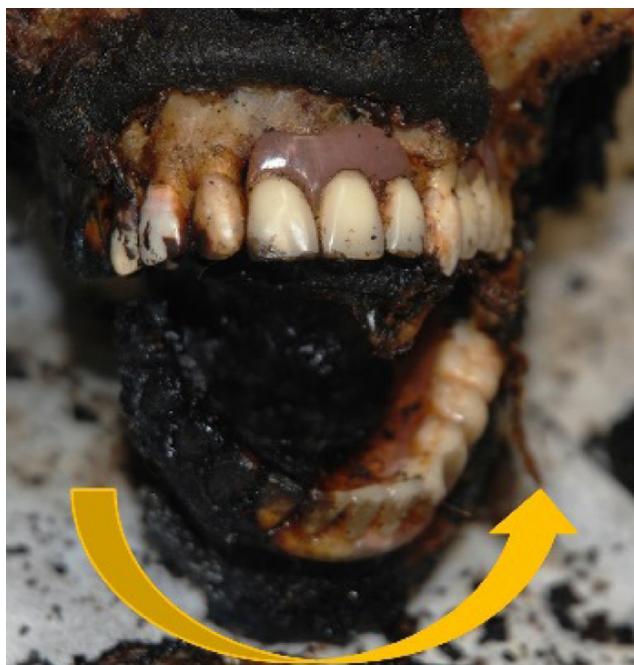
**Figure 3** Frontal view of the oral cavity.

Analysis of the intraoral cavity showed two acrylic resin removable prosthetic rehabilitations: both upper and lower. In the lower one, we can observe that the fire direction was from right to left and the fire intensity was higher on the right side than on the left side. The lower prosthetic rehabilitation was carbonized on the right side but not on the left side. The morphology of the acrylic teeth was conserved on the left side of the lower jaw. When we compared the upper and the lower rehabilitations, we observed that the fire intensity was higher in the lower one (Figure 3).

**Notes:** The direction of the fire was from the right to the left side of the skull (arrow). The intensity of the fire was higher on the right side.

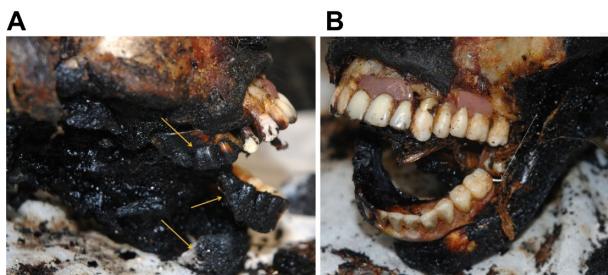
**Figure 4** The (A) right and (B) left lateral views of the oral cavity.

**Note:** The yellow arrows show alterations by fire on the bone and denture base.

the oral cavity was lightly burned (Figure 4). The lower rehabilitation had a stainless steel hook for the last tooth and was not burned or molten. This structure is different from the clasp unit of the direct retainer. The rehabilitation was manufactured with an alloy of cobalt–chromium–molybdenum, for which the melting point is higher than stainless steel.<sup>4</sup> On the right side of the oral cavity, we observed that the lower jaw was fully carbonized, with specific areas of the jaw calcined and missing (Figure 4). The lower acrylic resin removable prosthodontic rehabilitation was partially carbonized and was missing part of the base structure and some of the teeth.

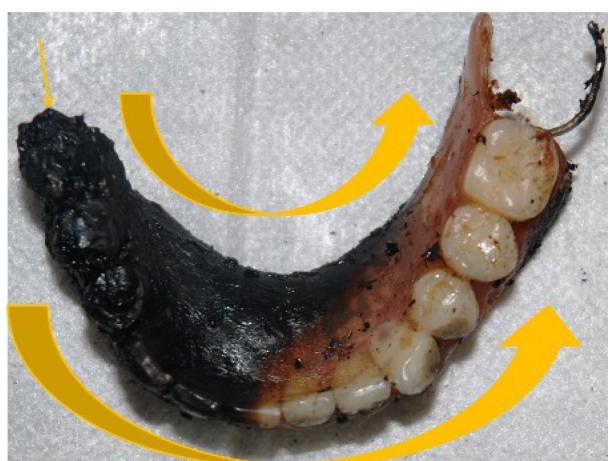
**Figure 5** Lower denture where the direction of the fire was from the right to the left side (large arrows), on the lingual and vestibular surfaces.

**Note:** The rehabilitation had a missing structure on the distal end of the right side (small arrow).

When we removed the lower denture, the fire intensity and the fire direction were the same in the vestibular and lingual surfaces of the rehabilitation. The right side of the rehabilitation was carbonized, and was missing the acrylic resin structure and likely a stainless steel hook at the distal end of the rehabilitation as well (Figure 5).

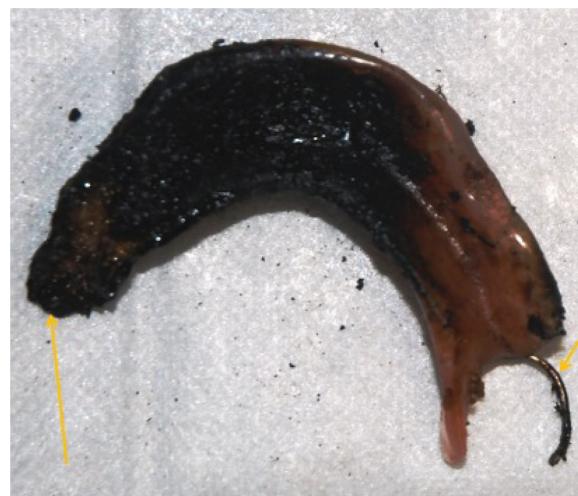
**Figure 6** Inside the base of the lower denture.

**Note:** The yellow arrow (left) shows the missing structure of the denture base, caused by the carbonization of the polymer. The yellow arrow (right) shows the stainless steel hook.

Inside the base of the lower denture, on the right side, the temperature was near 900°C, where was missing the thermosetting polymer structure of the rehabilitation (Figure 6). The left side of the rehabilitation structure was intact; it was not carbonized because the fire intensity was less than the thermosetting polymer carbonization temperature.

Another way of estimating the temperature is the presence of the stainless steel hook on the left side. This is a metal alloy of iron and carbon, which we call austenitic stainless steel, for which the melting point is 700°C.<sup>8</sup> On the left side, the temperature was less than 700°C, but if a hook was also present on the right side, the temperature would have been higher than this melting point temperature.

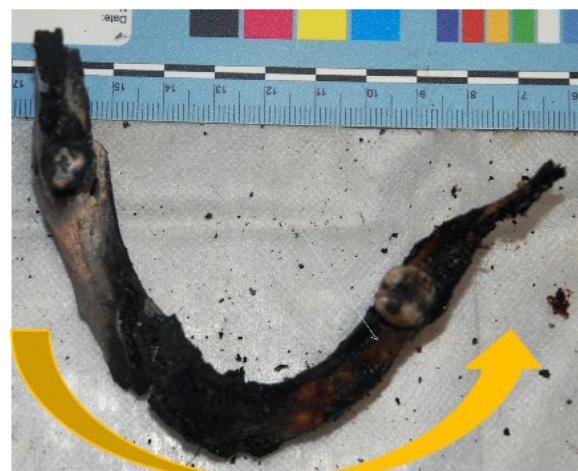
**Figure 7** Upper view of the lower jaw with color alteration of bone caused by the fire.

**Notes:** The arrow indicates that the direction of fire was from the right side to the left side of the mandible. The intensity of fire was higher on the right side.

The lower jaw mainly presented two different colors of the alveolar bone (Figure 7).<sup>9,10</sup> The alveolar bone was white on the right side and dark in front and on the left side of the mandible. These burn injury patterns again confirm the fire direction, from the right side to the left side. The bone was calcined on the right side of the mandible and was charred on the anterior, and slightly burned on the left side.

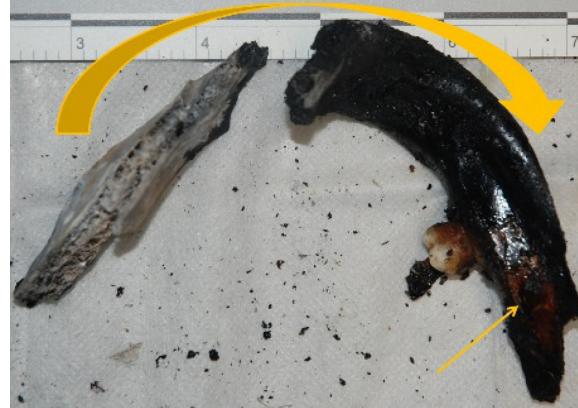
**Figure 8** The inferior border of the lower jaw with different patterns of burn damage.

**Notes:** The arrow on the right side indicates: Slightly burned on the distal end of the left side of the lingual surface of the mandible. The large arrow indicates the intensity of fire was higher on the right side of the jaw.

The lower border of the mandible showed the same pattern of the fire damage (Figure 8) in that it was white in the right side (calcined), black on the anterior and left sides (charred), and slightly burned on the distal end of the left side of the lingual surface of the mandible.<sup>6,7,11</sup> The lower jaw had two teeth: tooth 37 and tooth 47 (Figure 9) and both had antemortem dental restorations. The second

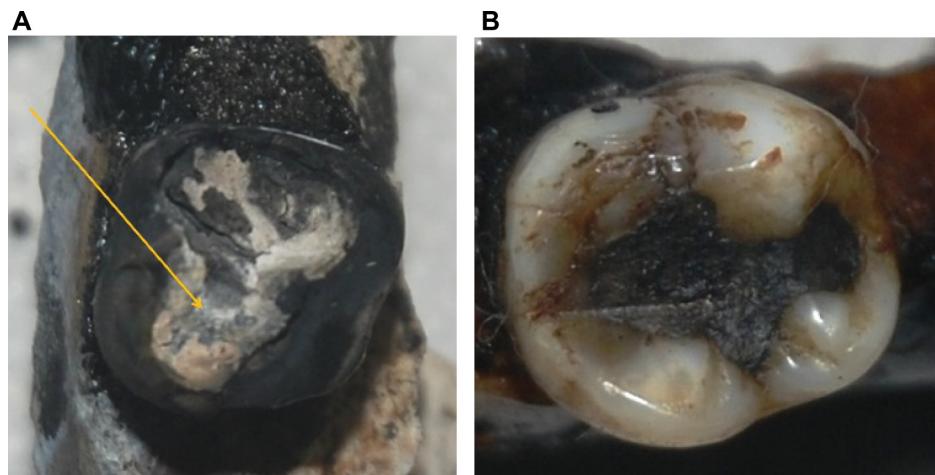
**Figure 9** The teeth (A) 47 and (B) 37.

**Notes:** (A) Tooth 47 without the alloy filling, which was molten. As indicated by the arrow; the alloy was molten and there were traces of residual alloy on the floor of the cavity. (B) Tooth 37 with the dark metal alloy filling.

molar from the left side on the occlusal surface had a restoration of amalgam (Figure 9). The filling was present but was dark. The second molar of the right side had a cavity compatible with an amalgam filling (Figure 9). The alloy was molten and there were traces of residual alloy on the floor of the cavity.

The amalgam filling consisted of a eutectic alloy. The advantage of these alloys is that the low melting point allows work in the mouth. Conventional amalgam restorations darkened and pulverized at 300°C and roasting began at 800°C.<sup>8</sup> At 1,000°C in situ in the filling, we only saw the shine of the silver in the second molar from the right side.<sup>12</sup> From the color of the filling from the second molar of the left side, we estimate that the fire temperature was near 300°C.

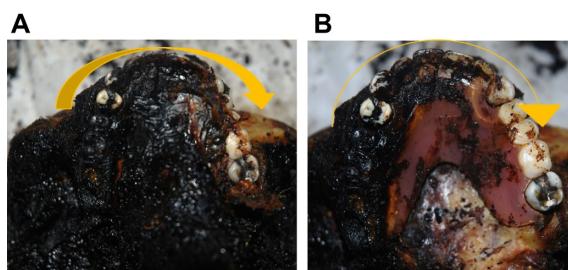
**Figure 10** (A) The upper jaw with the denture before removing the soft tissues and (B) after removing the soft tissues.

**Note:** The visual appearance of the upper jaw was also compatible with a fire direction from the right to the left (as shown by the arrows).

The visual appearance of the upper jaw was also compatible with a fire direction from the right to the left (Figure 10). The temperature intensity was higher on the right side than on the left. After removing the soft tissues and cleaning, the pattern injuries were the same in the lower

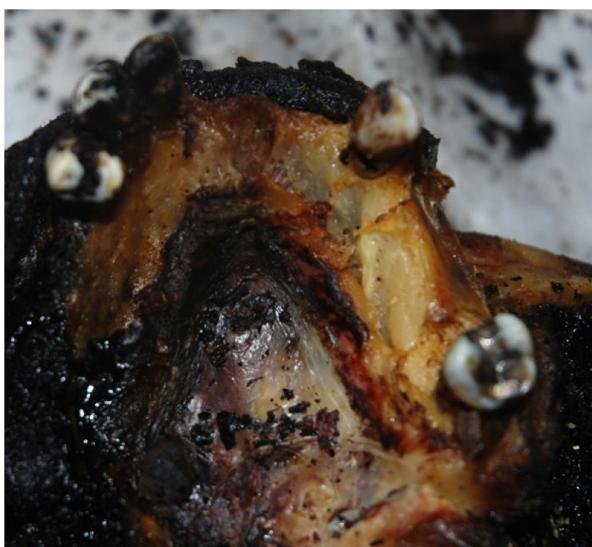
**Figure 11** The burn damage on the upper jaw bone.

jaw (Figures 10 and 11). The acrylic resin from the upper denture was carbonized on the distal end of the right side (Figure 12), and this pattern was the same on the inner surface (Figure 12).

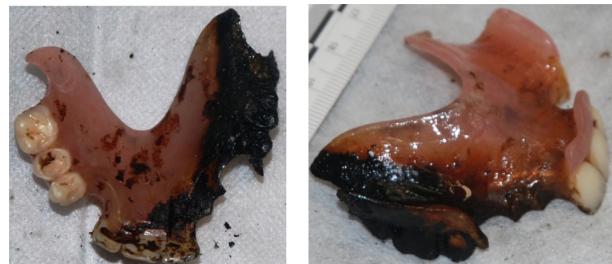
**Figure 12** The burn damage on the denture on the external and internal surfaces.
