# Sudden loss of the deep brain stimulation effect with high impedance without macroscopic fracture: a case report and review of the published literature

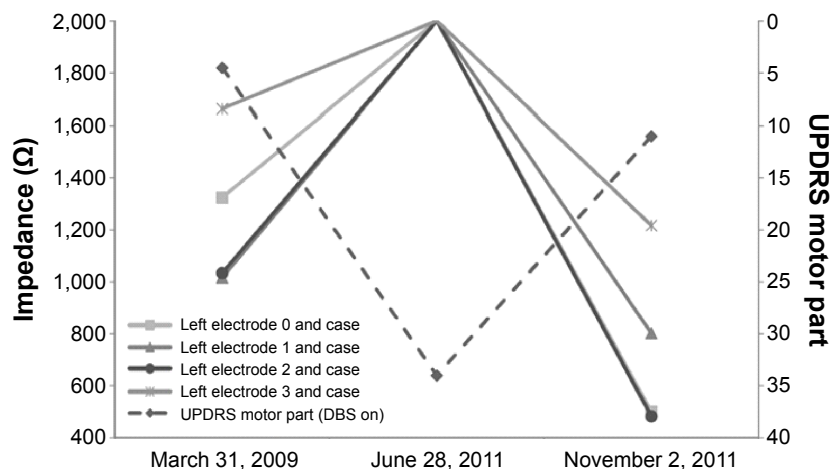
Prior to reoperation, her UPDRS motor scores with DBS stimulation were 34 with medication and 30 without (Figure 1). The scores without stimulation were 48 and 45, respectively. On June 29, 2011, the IPG was replaced under local anesthesia without any complications. Postoperatively, the patient's parkinsonian symptoms immediately improved under the same neurostimulator settings. The lead impedance readings on the left side were normalized. The extracted neurostimulator showed no visible signs of deformity. When tested with an oscilloscope at 1,000-Ω load impedance, the neurostimulator could produce stimulation waveforms. The destructive analysis by the manufacturer revealed that the case feed-through wire was lifted on the hybrid side, and this finding was consistent with the disconnection between the IPG hybrid circuit board and the connector block of the IPG header.

During a follow-up period of 4 months with amantadine at 300 mg/day, no recurrence of parkinsonian symptoms or high impedance measurements were reported. On November 2, 2011, her UPDRS motor scores were 11 with DBS stimulation and 34 without (Figure 1). In the 2 years after

**Figure 1** Changes in lead impedances and UPDRS motor part scores before and after neurostimulator replacement. **Abbreviations:** DBS, deep brain stimulation; UPDRS, unified Parkinson's disease rating scale.
