Supplementary Figures

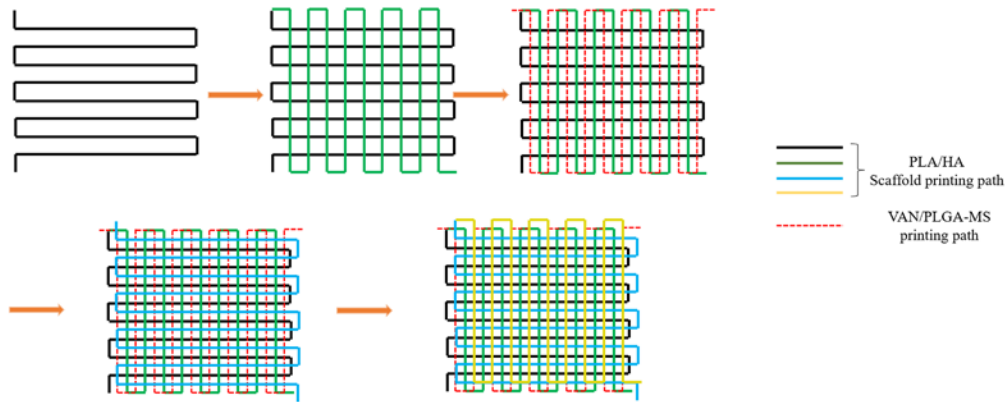
Figure S1 The whole printing idea of VAN/MS-PLA/n-HA composite scaffolds.

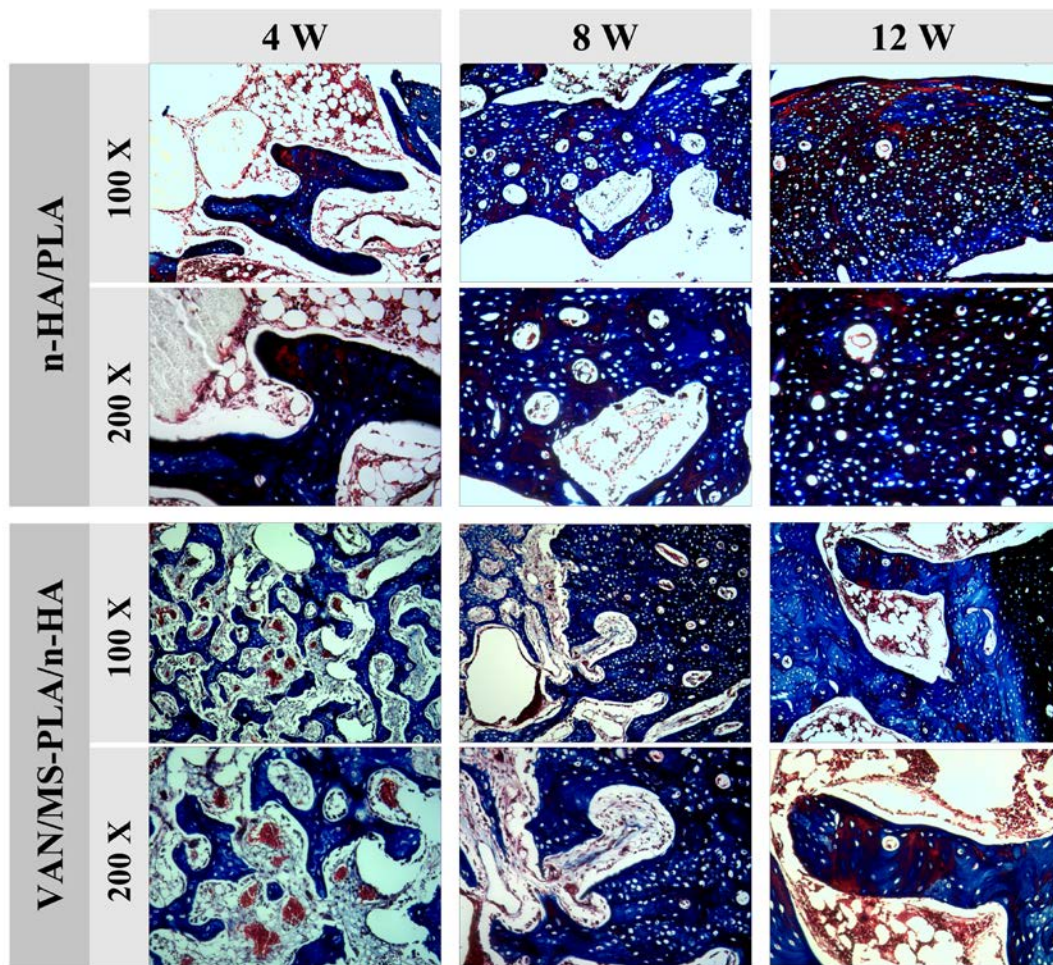
Figure S2 Observation of Masson trichrome staining on the defect of femur in different scaffold groups at 4,8,12 weeks after operation.
