Aesthetic Management of Erosive Tooth Wear in a Young Egyptian Swimmer: A Case Report

Purpose: This case report discusses the management of a young, Egyptian swimmer complaining of tooth sensitivity associated with erosive tooth wear. Anterior teeth were restored using the injection molding technique, also known as the injectable composite resin technique, to overcome the patient's complaint and enhance the aesthetics of compromised anterior teeth.

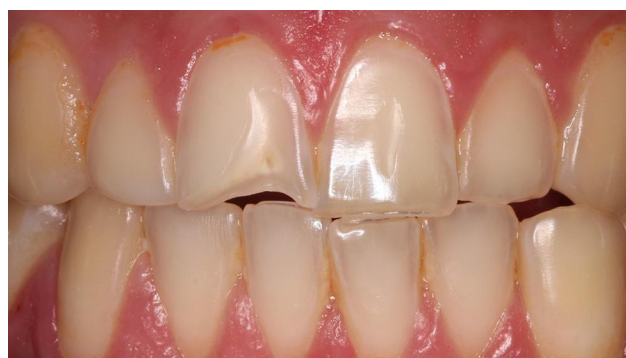
Clinical examination showed tooth wear related to the maxillary and mandibular anterior teeth, more distinctively affecting both upper central incisors and maxillary left lateral incisor. Those teeth presented loss of anatomy affecting their smooth surfaces and were shiny in appearance with the dentine color more evident. The pattern of tooth wear seemed similar to preparations for aesthetic

veneers. Moreover, a moderate sized fracture associated with the upper right central incisor was seen, which the patient does not recall how it happened, but it caused the sensitivity complaint to cold and hot stimuli due to frank dentine exposure. The patient has no carious lesions anteriorly or posteriorly. Significant malalignment was observed in the mandibular arch. Plaque deposits and marginal gingivitis were also apparent on periodontal examination (Figures 1–3).

Figure 1 Frontal view of anterior teeth.

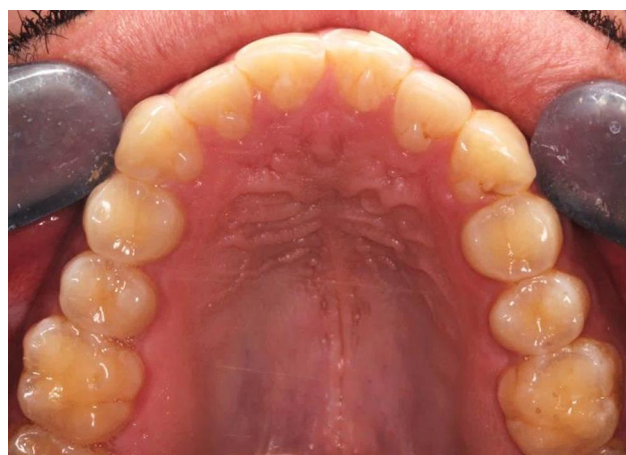
Figure 2 Occlusal view of the maxillary arch.

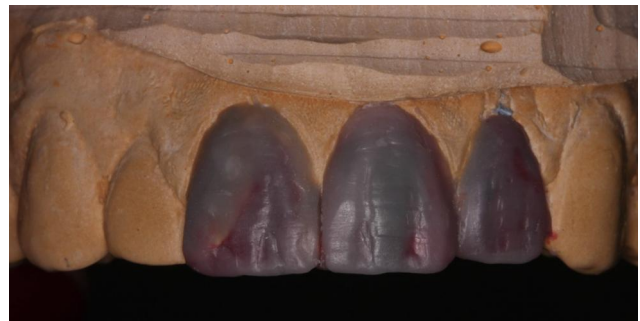
Figure 4 Diagnostic wax-up.

central incisor using a light cured resinous temporary material to overcome the patient's sensitivity. The restorative treatment plan was discussed with the patient and it was decided to restore only the teeth that are mostly affected by tooth surface loss using direct resin composite restorations. The remaining teeth suffering from some degree of erosive tooth wear, for example incisal thirds of mandibular anterior teeth, presented no complaints whether aesthetically or sensitivity, thus monitoring of those lesions was favored. A diagnostic wax-up was made by the laboratory technician (Figure 4) and a silicone index was used for fabrication of a mock-up (Figure 5).

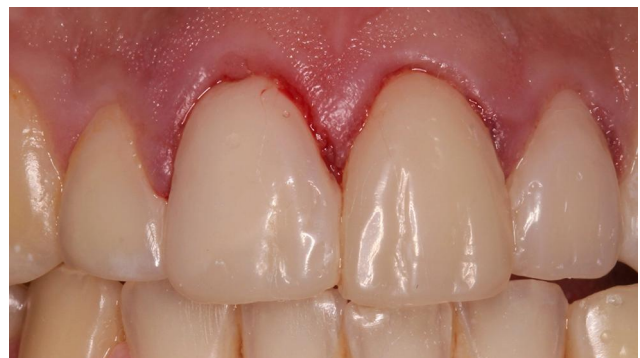
Figure 5 Intraoral mock-up.

The mock-up was left for a week for biological and functional assessment before receiving the permanent restorations. The injection molding technique, also known as the injectable composite resin technique, using highly filled injectable resin composite was chosen for aesthetic restoration of this case. The same wax-up was used for fabrication of a vacuum pressed vinyl sheet splint, which was injected with a clear polyvinyl siloxane material (DENU Trans Sil, HDI Inc., Seoul, Republic of Korea) to record finer details of the wax-up and provide better adaptation and stabilization of the splint

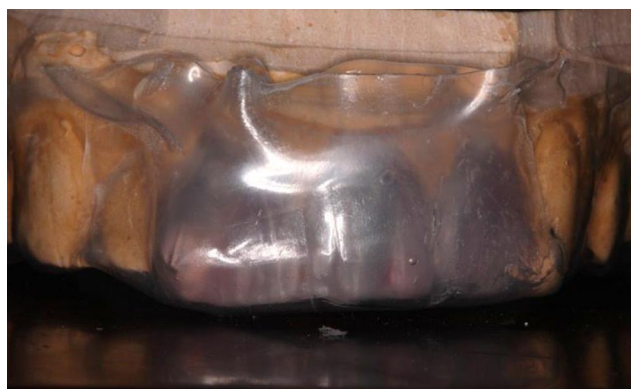
Figure 6 Splint injected with clear PVS and seated on the cast.

(Figure 6). Holes were drilled through the materials to provide a pathway through which the tip of the injectable composite syringe can be inserted.

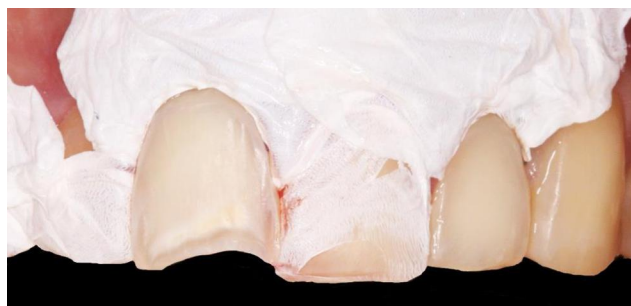
Figure 7 Isolation of adjacent teeth using Teflon tape during restoration of maxillary right central incisor and left lateral incisor.

On the recall visit, shade selection was done and the mock-up was removed, teeth were prepared using abrasive discs (Polishing Discs № 1.071, TOR VM, Moscow, Russia) to remove any debris from the mock-up and provide a better surface for bonding procedures. For isolation, a soft, flexible cheek and lip retractor was used (Optragate, Ivoclar Vivadent, Schaan, Liechtenstein), this was followed by placement of retraction cords into the gingival sulci and a Teflon napkin gingivally and on every other tooth for maximal isolation (Figures 7 and 8). Teflon tape must cover the teeth adjacent to the one to be restored. Selective enamel etching was done for 15 seconds and the area where dentine was exposed in the maxillary right central was avoided during the etching procedure. A one component light-cured universal adhesive (G-Premio Bond, GC Corp, Tokyo, Japan) was applied on the tooth structure and cured for 10 seconds, according to manufacturer instructions. Afterwards, the splint was placed intraorally and

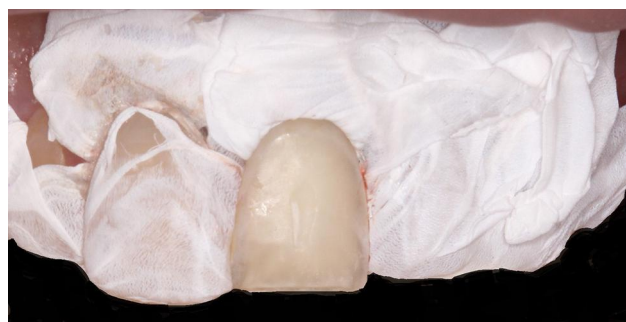
Figure 8 Isolation of adjacent teeth using Teflon tape during restoration of maxillary left central incisor.

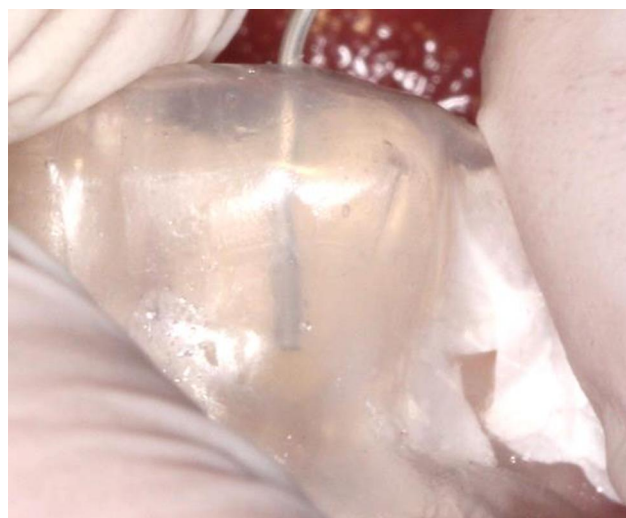
Figure 9 Tip of the injectable composite resin syringe inserted into the space created by the wax-up.

stabilized in place. The injectable resin composite (G-aenial Universal Flo, GC Corp, Tokyo, Japan) was injected through the drilled holes and cured for 20 seconds, according to manufacturer instructions (Figure 9). After the three teeth were restored consecutively, Teflon was removed and finally finishing and polishing procedures were done using abrasive discs and a polishing kit (DIACOMP® PLUS RA, EVE Ernst Vetter GmbH, Germany) (Figures 10–12).

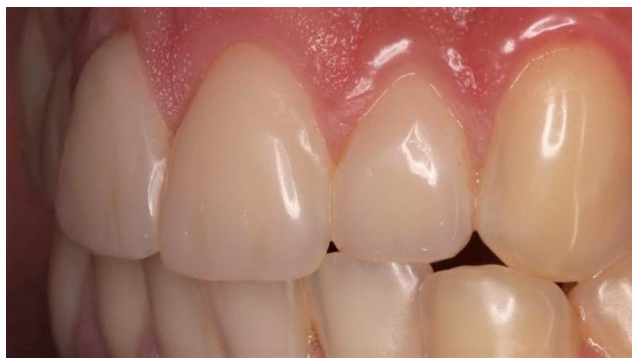
Figure 10 Final restorations.

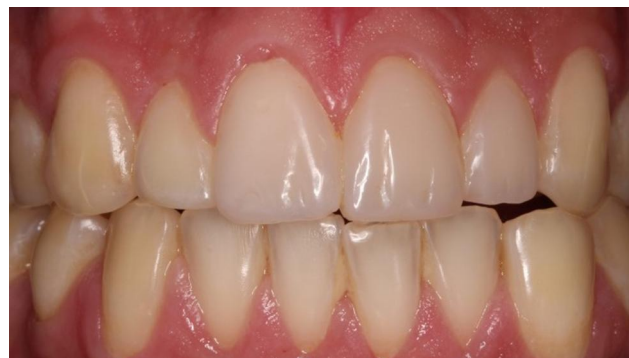
Figure 13 Follow-up photograph after 8 weeks.

After 8 weeks, the patient was asked to come in for a follow-up. He had no complaints and was pleased with the treatment provided. Gingival health was satisfactory with some residual marginal inflammation (Figures 13 and 14). The patient still used the vertical “scrubbing”

technique for tooth brushing which could explain the residual gingivitis; thus, proper oral hygiene measures were, once again, explained to the patient and the correct tooth brushing method was demonstrated in front of the patient.

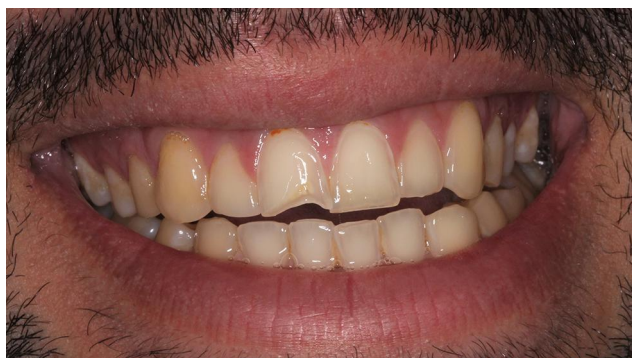
Figure 11 Preoperative smile.

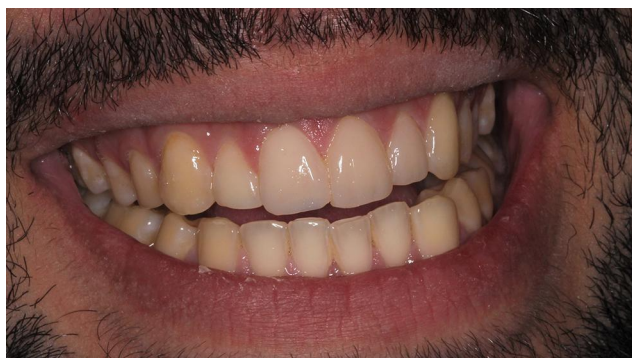
Figure 12 Postoperative smile.
