# Stress Analysis on Mesiolingual Cavity of Endodontically Treated Molar Restored Using Bidirectional Fiber-Reinforced Composite (Wallpapering Technique)

**Purpose:** This research is to determine the stress distribution of a fiber-reinforced composite made of polyethylene and e-glass on the mesiolingual cavity of ETT.

**Materials and Methods:** A three-dimensional model of the mandibular molar was prepared for cavity preparation and the formation of restorations using SolidWorks 2021. The models were analyzed with Abaqus 2020 to determine stress concentrations after given vertical and oblique loading.

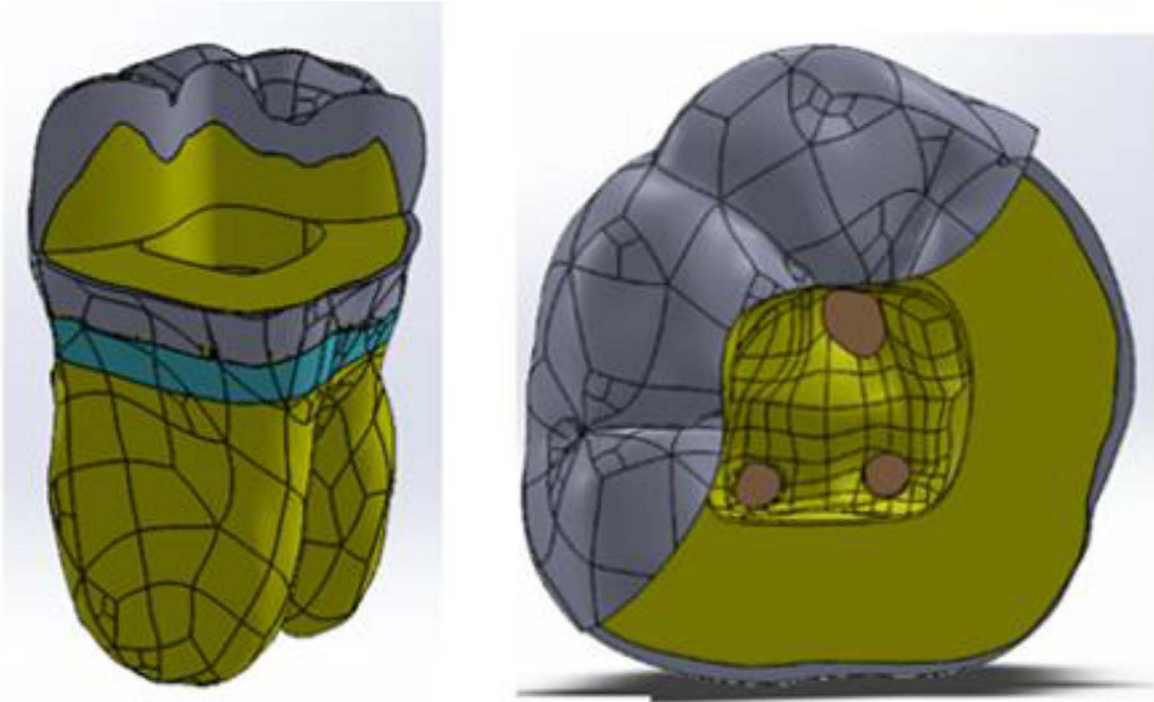
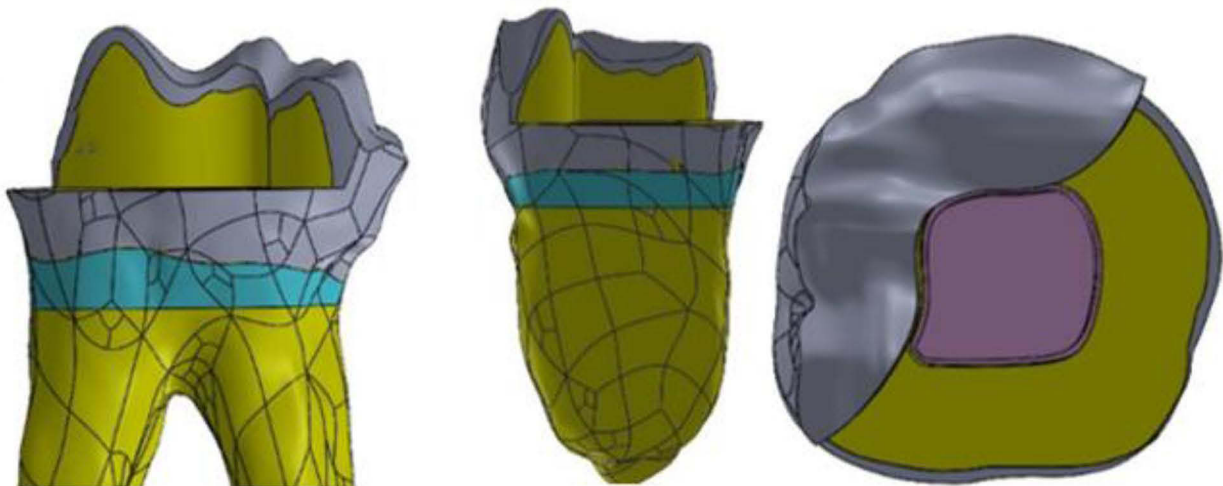
**Figure 1** (A) Non cuspal coverage and (B) cuspal coverage cavity design.

Finite element analysis is conducted by using Abaqus 2020 to obtain the data. The research material was a three-dimensional (3D) solid model of the mandibular right first molar. A 3D Model was obtained by following several procedures. First, the tooth was scanned using the Micro-CT (computerized tomography) scanner. Then, the results were processed using software to create a proper 3D model. The processes include point cloud data reduction and imperfection cleaning to prevent misinterpretation. After the modifications were completed, the 3D solid model was generated from the point cloud data and imported into 3D Modeling Software for further preparation. The components of the 3D solid model of a molar tooth have been prepared for root canal treatment, consisting of enamel, dentin enamel junction (DEJ), dentin, cemento-enamel junction, cementum, gutta-percha, periodontal membrane, alveolar bone, and smart dentin replacement (SDR) flowable composite. The cavity was modified using SolidWorks 2021, and the criteria for cavity design on the lower molar were prepared without mesial and lingual walls listed in [Table 1](#). The subject of research was divided into non-cuspal coverage ([Figure 1A](#)) and cuspal coverage ([Figure 1B](#)). The restoration was built using the

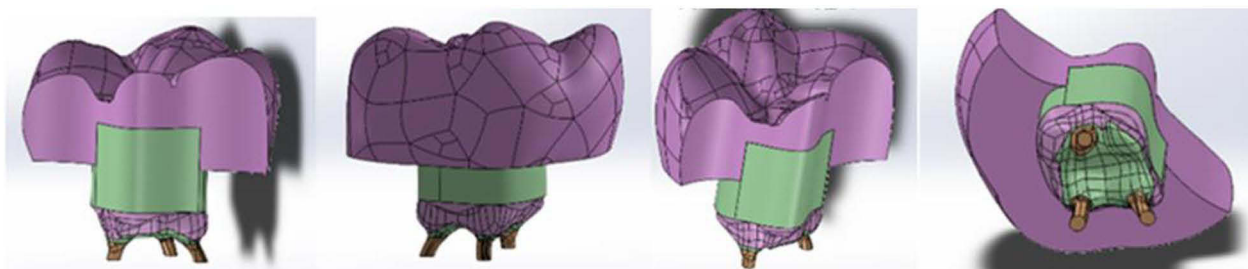
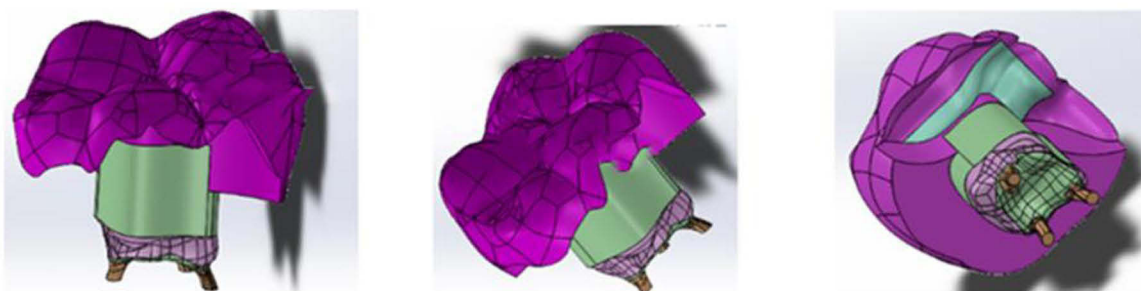
**Figure 2** Components of 3D direct restoration reinforced fiber composite (A) non-cuspal coverage and (B) cuspal coverage.

wallpapering technique, and the materials used are listed in [Table 2](#). The fiber-reinforced composite restoration that has been applied can be seen in [Figure 2](#). The types of fiber materials used are polyethylene fiber and e-glass fiber.

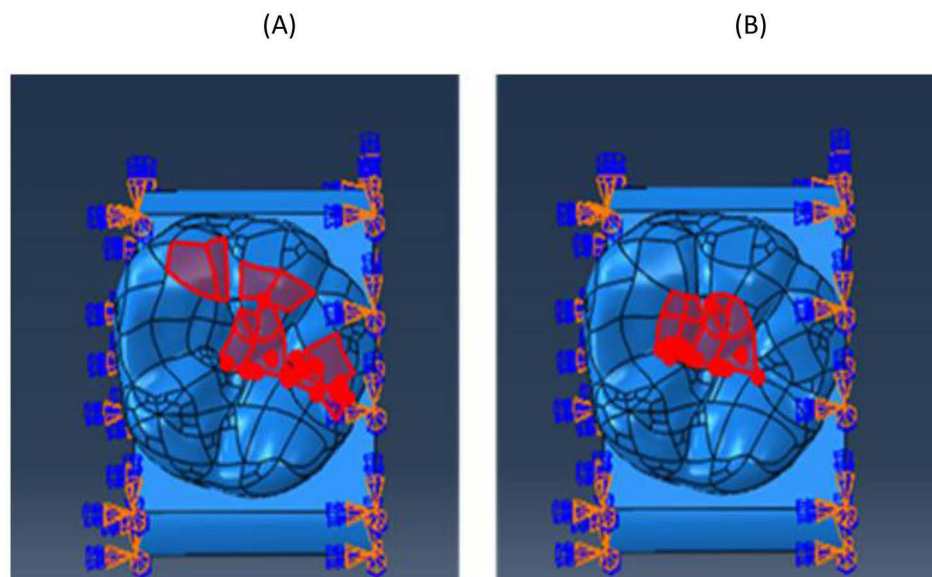
**Figure 3** The loading zone (A) vertical force and (B) oblique force are represented by the red region.

The tooth model was assumed to be homogeneous, linear elastic, and isotropic, while the fiber component was considered orthotropic. The surface-based cohesive interaction was given to the interaction between the tooth and the restoration. The interaction of layers that are not perfectly adhered was given material properties consisting of shear bond strength and tensile bond strength using a self-etch adhesive system. The modulus elasticity of the hybrid layer model was 11,765 MPa and thickness was 5  $\mu\text{m}$ .<sup>25</sup> Two loading conditions applied to the occlusal surface were 720 Newton (N) of vertical force and 200 N of oblique force at a 45° angle (Figure 3).

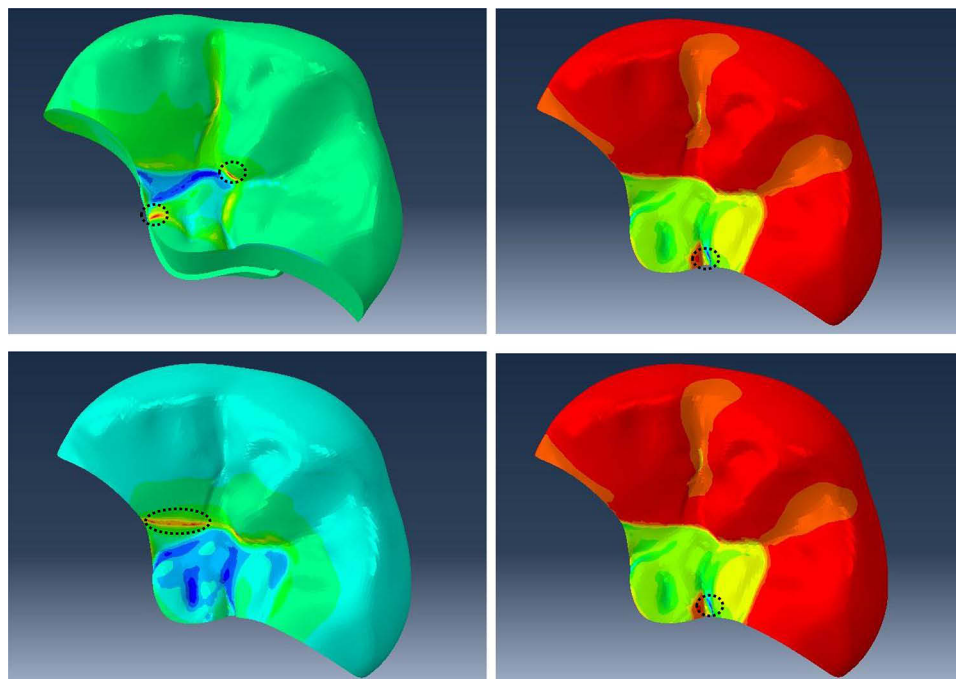
**Figure 4** The black dashed circles is the location of high-stress concentration on a fiber-reinforced composite of polyethylene non-cuspal coverage (PNCC). The red area is the maximum principal stress on the surface of the restoration when a vertical force (above) and an oblique force (below). The blue area is the minimum principal stress on the surface of the restoration when a vertical (above) and an oblique force (below).

Stress distribution on tooth structure and restoration when vertical and lateral forces were applied are shown in Figures 4–7. Stress concentrations of restoration occurred on the distolingual cusp, marginal ridge distal, occlusal groove, and CEJ. However, in this area, there is no failure because the strength of the material is greater than the maximum principal stress and minimum principal stress. Structural failure was seen in e-glass fiber. Failure occurred on the base and circumferential fiber, whereas on the cuspal coverage group occurred at the base fiber because of compressive stress.

Figure 4 shows the location of high stress on a fiber-reinforced composite of polyethylene non-cuspal coverage (PNCC). The maximum principal stress and minimum principal stress occur on the fissure when vertical loading (upper) and oblique loading (below) are applied. Sharp angles and narrow curvatures within fissure systems have the potential to produce stress concentration and crack initiation. Figure 6 illustrates this as well. On a fiber-reinforced composite with polyethylene cuspal coverage (PCC), the high-stress concentration was located on the fissure; nonetheless, failure has not occurred because the maximum and minimum principal stress do not exceed the material strength (Table 7).

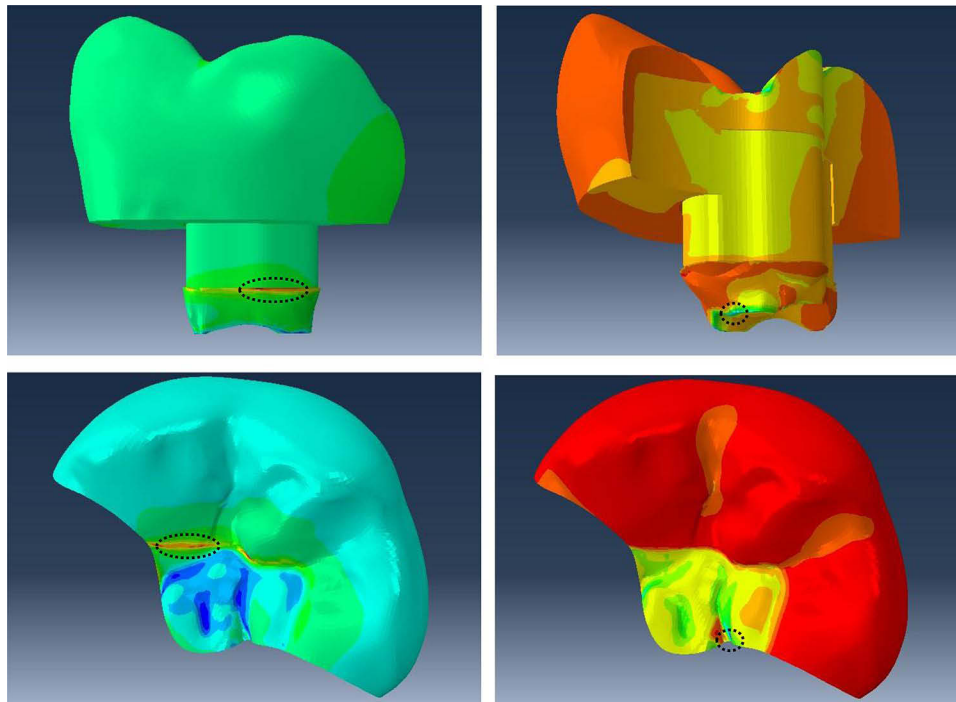
**Figure 5** The black dashed circles is the location of high-stress concentration on a fiber-reinforced composite of e-glass fiber non-cuspal coverage (ENCC). The red area is the maximum principal stress on the surface of the restoration when a vertical force (above) and an oblique force (below). The blue area is the minimum principal stress on the surface of the restoration when a vertical (above) and an oblique force (below).

Figure 5 shows the location of high-stress concentration on a fiber-reinforced composite of e-glass fiber non-cuspal coverage (ENCC). The stress location occurs on the circumferential fiber, base fiber, and fissure. A failure occurred on the circumferential fiber due to the maximum principal stress exceeding the tensile strength of the fiber component (Table 6) when vertical force was applied. A failure also occurred on base fiber due to the maximum and minimum principal stress exceeding the material strength when vertical force was applied, and when oblique forces were applied, failure occurred due to the maximum principal stress exceeding the tensile strength of e-glass fiber (Table 6).

The failure occurred on the base and circumferential structure of e-glass fiber reinforced composite (Figures 5 and 7) when vertical force was due to tensile and compressive stress, while oblique force was applied due to tensile forces. In circumferential fiber failure occurs when vertical force due to tensile force results in stress concentration that exceeds the strength of the material. Restoration materials should have a modulus of elasticity similar to dentin (17.8 GPa) to create a homogeneous stress distribution and reduce the incidence of root fracture.<sup>7,12,40,41</sup> The results showed the stress concentration on polyethylene fiber-reinforced composite restorations did not exceed the strength of the materials. E-glass fiber has an elastic modulus of 8.87 GPa. Composite and polyethylene fiber has elastic modulus close to dentin 20.4 GPa and 23.6 GPa. Yamanel et al investigated the materials that had a high modulus of elasticity which tended to concentrate more stress within the restoration, whereas materials that had a low modulus of elasticity tended to transfer more stress to the tooth structure affected a greater risk of fracture.<sup>42-44</sup> Materials had a lower modulus of elasticity experienced greater strain when a force was applied.<sup>33</sup>

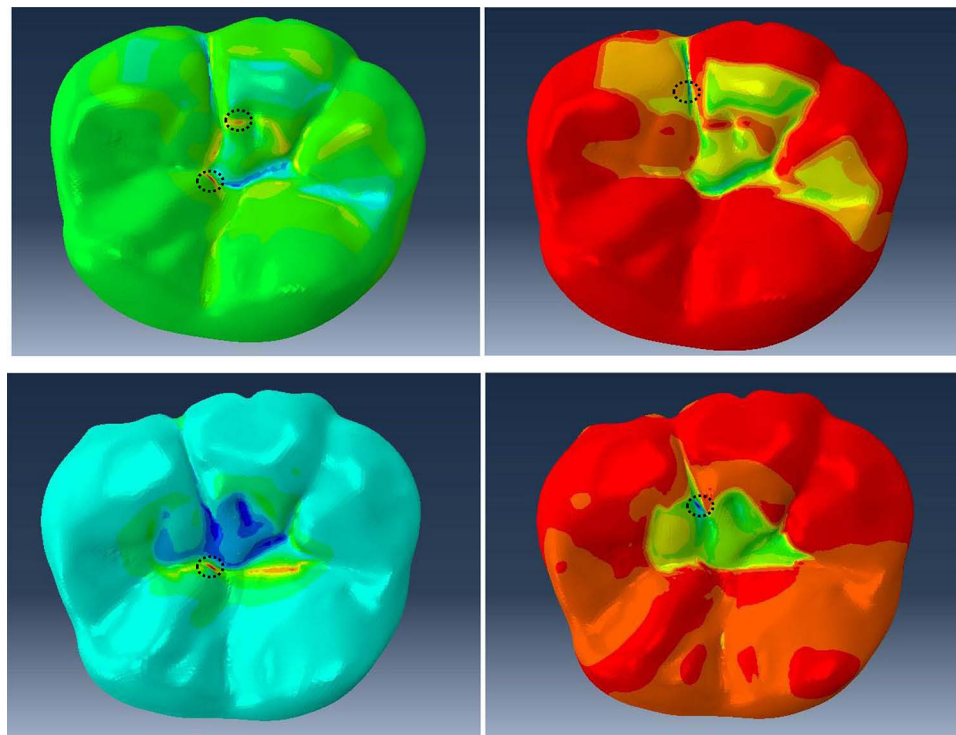
**Figure 6** The black dashed circles is the location of high-stress concentration on a fiber-reinforced composite of polyethylene cuspal coverage (PCC). The red area is the maximum principal stress on the surface of the restoration when a vertical force (above) and an oblique force (below). The blue area is the minimum principal stress on the surface of the restoration when a vertical (above) and an oblique force (below).

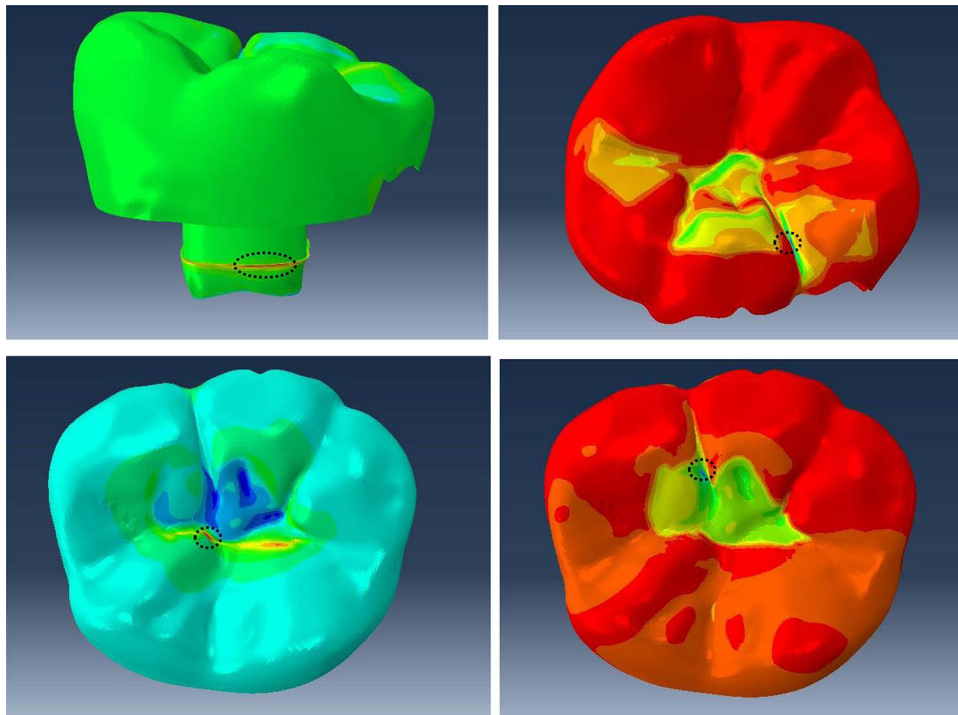
**Figure 7** The black dashed circles is the location of high-stress concentration on a fiber reinforced composite of e-glass fiber cuspal coverage (ECC). The red area is the maximum principal stress on the surface of the restoration when a vertical force (above) and an oblique force (below). The blue area is the minimum principal stress on the surface of the restoration when a vertical (above) and an oblique force (below).

Figure 7 shows the location of high-stress concentration on a fiber-reinforced composite of e-glass fiber cuspal coverage (ECC) occurs on the fissure and base fiber. The failure occurred on the base fiber when vertical force was applied due to the minimum principal stress exceeding the compressive strength of the fiber (Table 8).

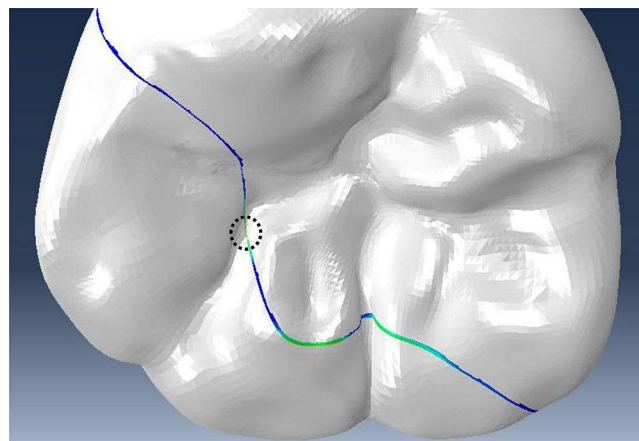
**Figure 8** Shows where high-stress concentrations are found on the PNCC interfacial surface. The restoration underwent a debonding initiation, as indicated by the dashed black circle, wherein the contact stress ratio reached a value of 1 at the enamel fissure.

Based on Equation (1), debonding initiation will occur if the contact stress ratio reaches a value of 1. **Figure 8** shows the location of high-stress concentrations in the interfacial surface of PNCC. The failure occurred on the enamel surface when vertical force was applied (**Table 9**), thus debonding between tooth and restoration. **Figure 9** shows the location of

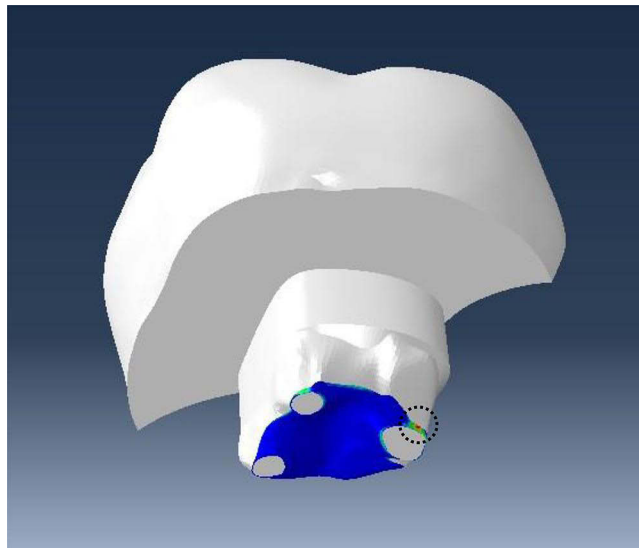
**Figure 9** Shows where high-stress concentrations are found on the ENCC interfacial surface. The restoration underwent a debonding initiation, as indicated with the dashed black circle, wherein the contact stress ratio reached a value of 1 at the distal region on the base fiber.

high-stress concentrations in the interfacial surface of ENCC, debonding between teeth and restoration occurred on the base fiber when oblique force was applied (Table 9). Figure 10 shows the stress location on the interfacial surface of PCC. Debonding occurred on the enamel surface when vertical loading was applied (Table 9). Figure 11 shows the stress location on the interfacial surface of ECC. Debonding occurs on the base surface when vertical and oblique forces are applied.

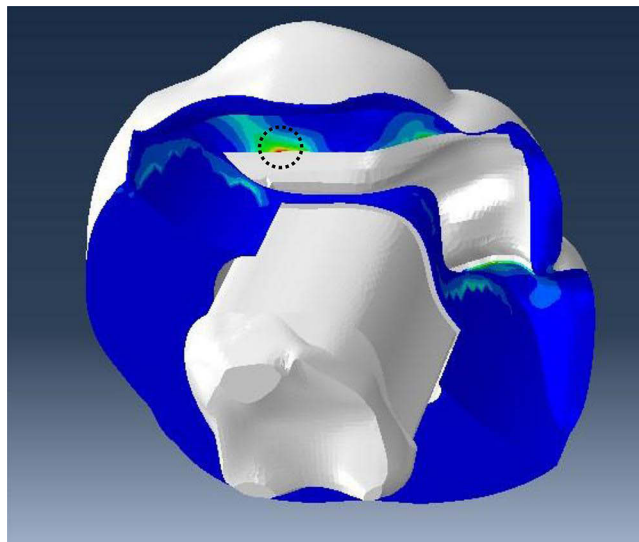
**Figure 10** Shows where high-stress concentrations are found on the PCC interfacial surface. The restoration underwent a debonding initiation, as indicated with the dashed black circle, wherein the contact stress ratio reached a value of 1 at the fiber occlusal between the enamel and the restoration.

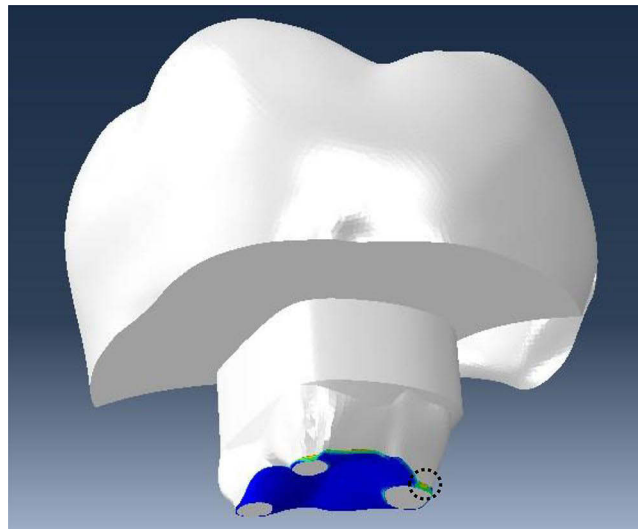
**Figure 11** Shows where high-stress concentrations are found on the ECC interfacial surface. The restoration underwent a debonding initiation, as indicated with the dashed black circle, wherein the contact stress ratio reached a value of 1 at the distal region on the base fiber.
